## Building Inspection Report

Type of Report: New Building Inspection - Pre Slab Stage

Building Inspection Report

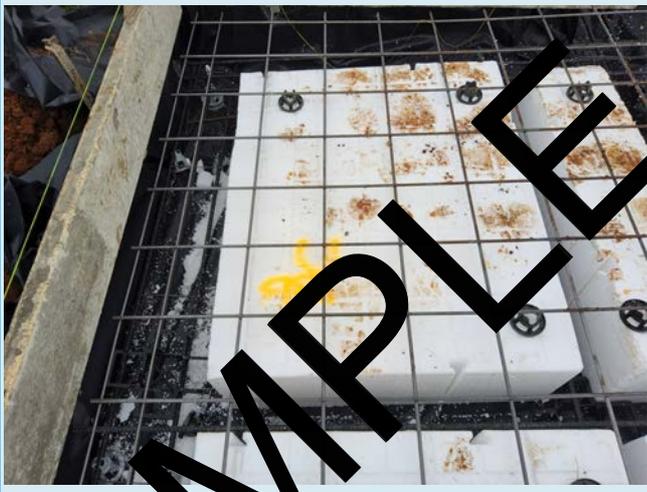
Pre-slab inspection	
Minor and/or Major Defect	Steel Placement & Fixing

Garage, left elevation, right hand side, it is noted that a bar chair will need to be installed to support the reinforcing mesh.

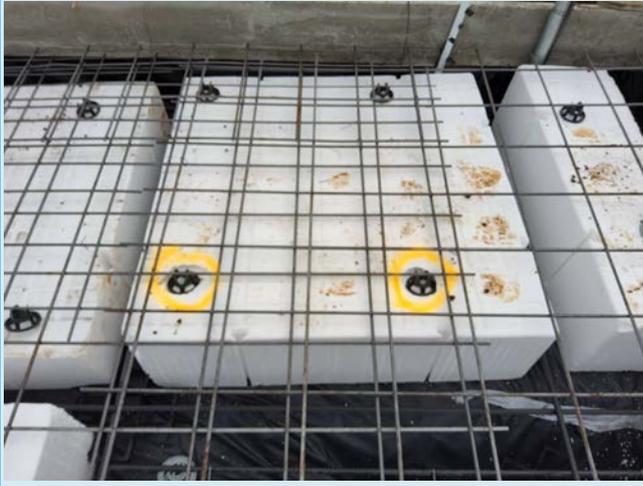
Pre-slab inspection	
Minor and/or Major Defect	Steel Placement & Fixing

Bedroom 2, right elevation it is noted that the bar chairs will need to be adjusted to support the reinforcing mesh.

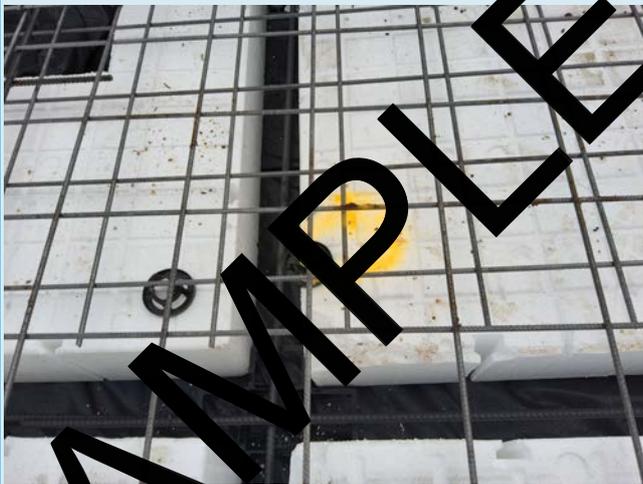
Pre-slab inspection	
Minor and/or Major Defect	Steel Placement & Fixing

Bathroom centre area, it is noted that the bar chair will need to be adjusted to support the reinforcing mesh.

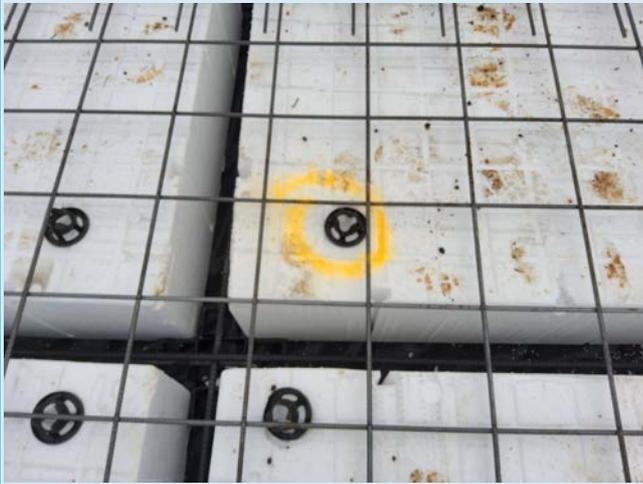
**Steel Placement & Fixing**

Kitchen centre area, it is noted that the bar chair will need to be adjusted to support the reinforcing mesh.

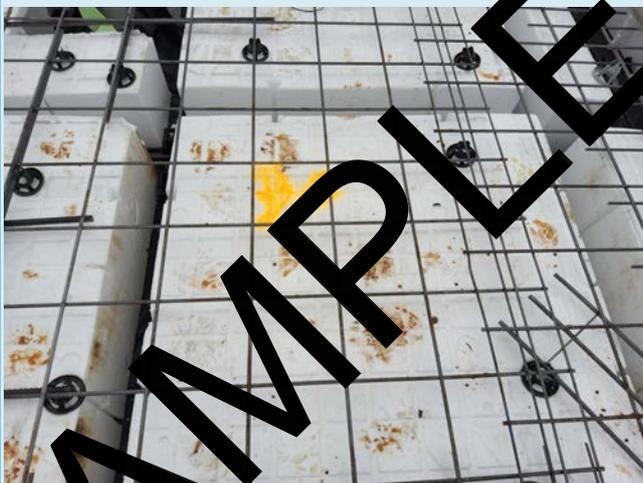
**Steel Placement & Fixing**

Family front elevation, it is noted that a bar chair will need to be installed to support the reinforcing mesh.
